# Yankee Fork Restoration Project

Baseline water quality data--Yankee Fork Salmon River

February 1, 2021-January 31, 2022

Annual Report 2021

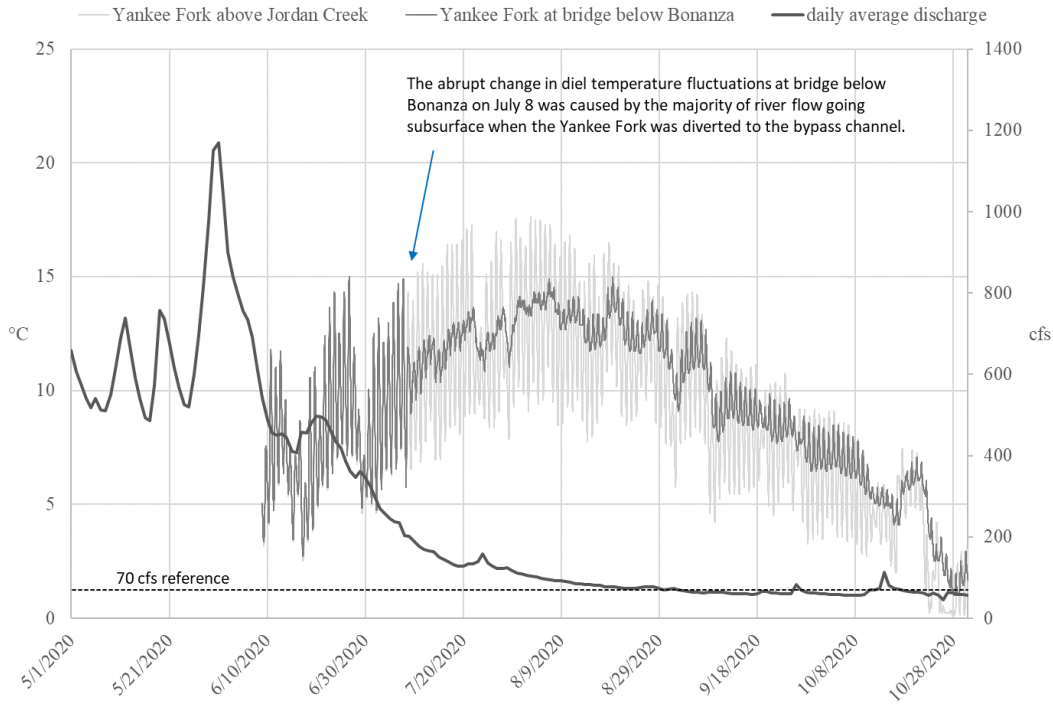
**Figure 21. 2020 Yankee Fork above Jordan Creek and at bridge below Bonanza stream temperature comparisons and daily average discharge at USGS Gauge 13296000 at mouth, and 70 cfs reference line for when entire flow went subsurface through the Bonanza Rehabilitation Project reach.**

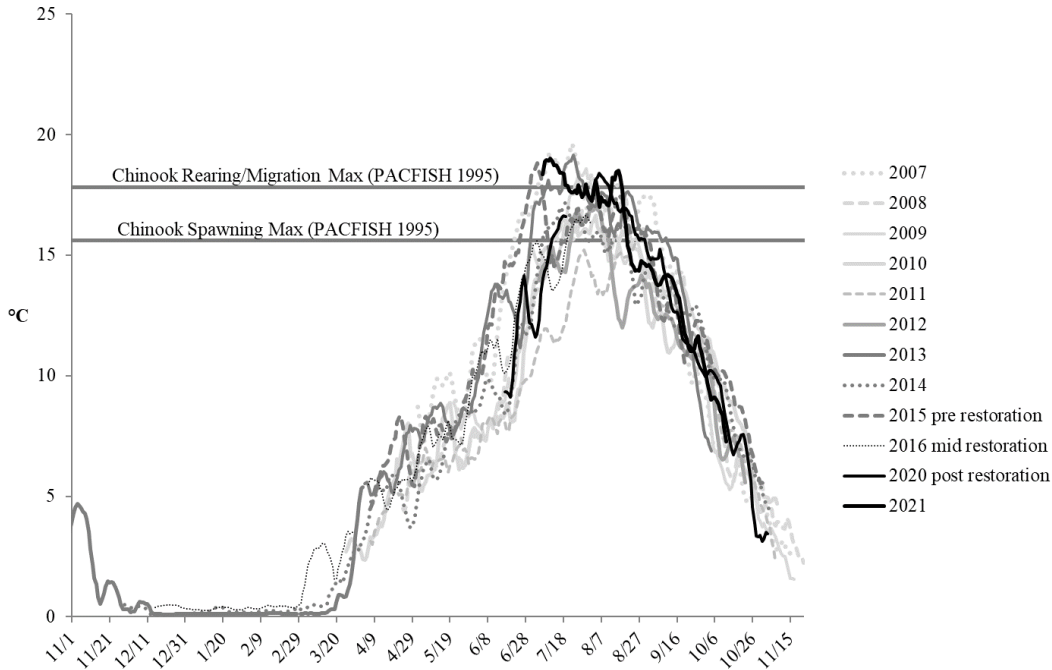
**Figure 27. West Fork Yankee Fork at mouth at old location prior to the West Fork Confluence Restoration Project, from 2007 to 2015, then gradually combined with YFSR water during the West Fork confluence restoration project in 2016, and after restoration at new location in 2020 and 2021, 7-day running average maximum water temperatures, using Onset HOBO (SBT) and Tidbit (USFS) dataloggers and SONDE temperature probe.**

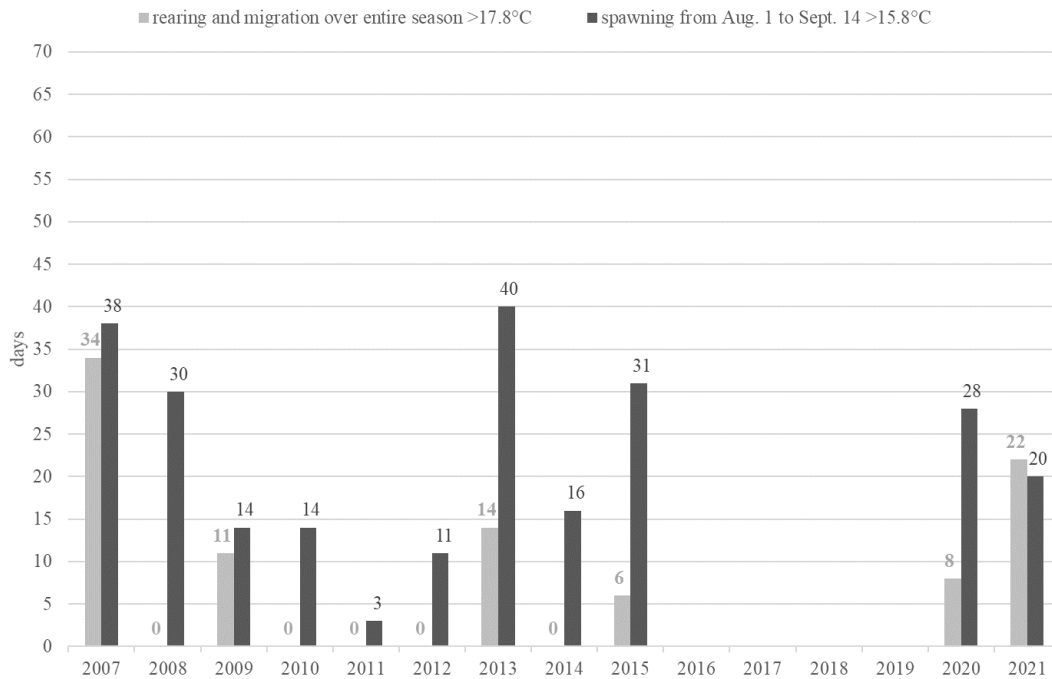
**Figure 28. West Fork Yankee Fork at old mouth, 2007-2015, and new mouth from 2020-2021, number of days the 7-day running average maximum water temperatures exceeded PACFISH recommended thresholds of 17.8°C for Chinook salmon rearing/migration over entire season, and 15.8°C during spawning, from August 1 to September 14, using Onset HOBO dataloggers.**

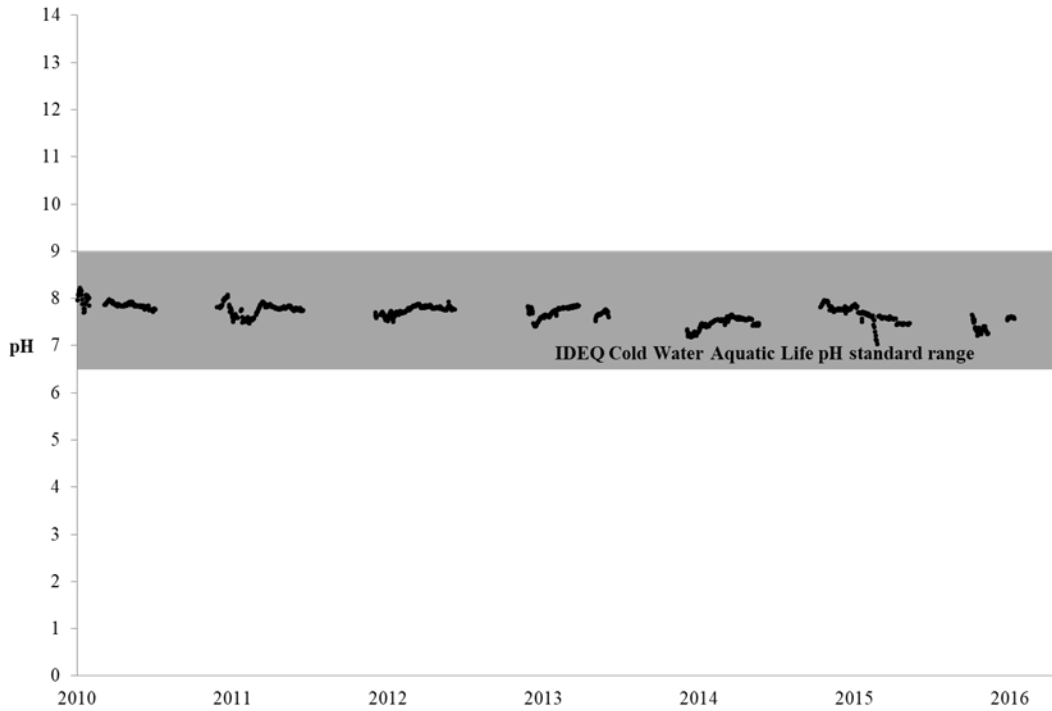
**Figure 97. pH daily average at old mouth of the West Fork Yankee Fork from 2010 to 2016, compared to IDEQ Cold Water Aquatic Life Use recommended range.**
