AN INVENTORY OF THE FLATHEAD RIVER AND TRIBUTARIES

Prepared by G. B. Caw

Fish and Wildlife Branch

January, 1976

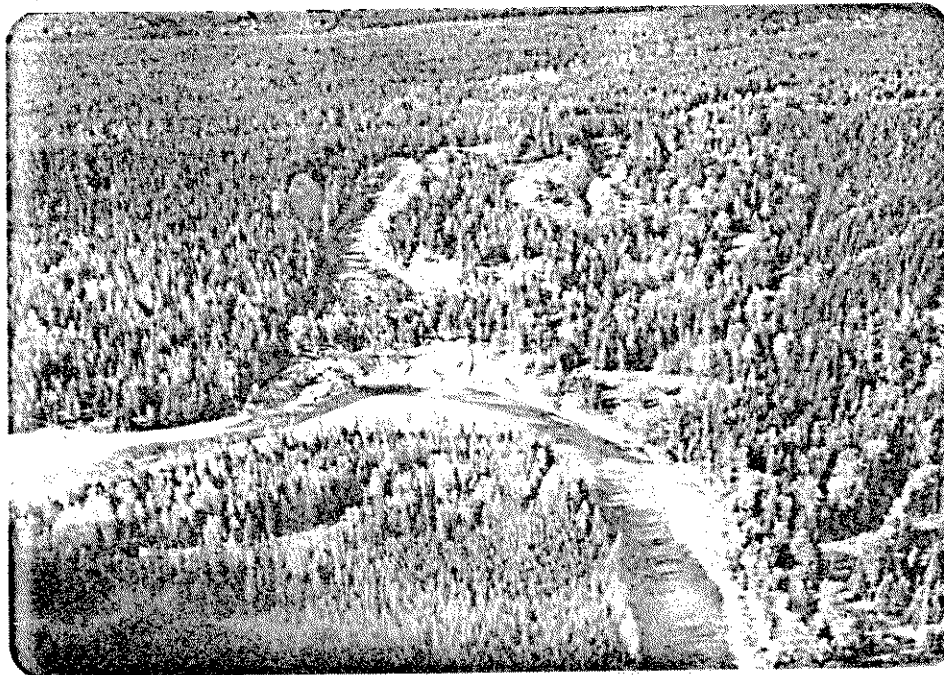
Picture 2 - A section of the transition area between reaches I & II.
The high steep exposed clay bank illustrated in the picture
is a common feature of the upper $\frac{1}{2}$ of reach I, and the lower
 $\frac{1}{2}$ of reach II. Firm compaction gives these banks stability.

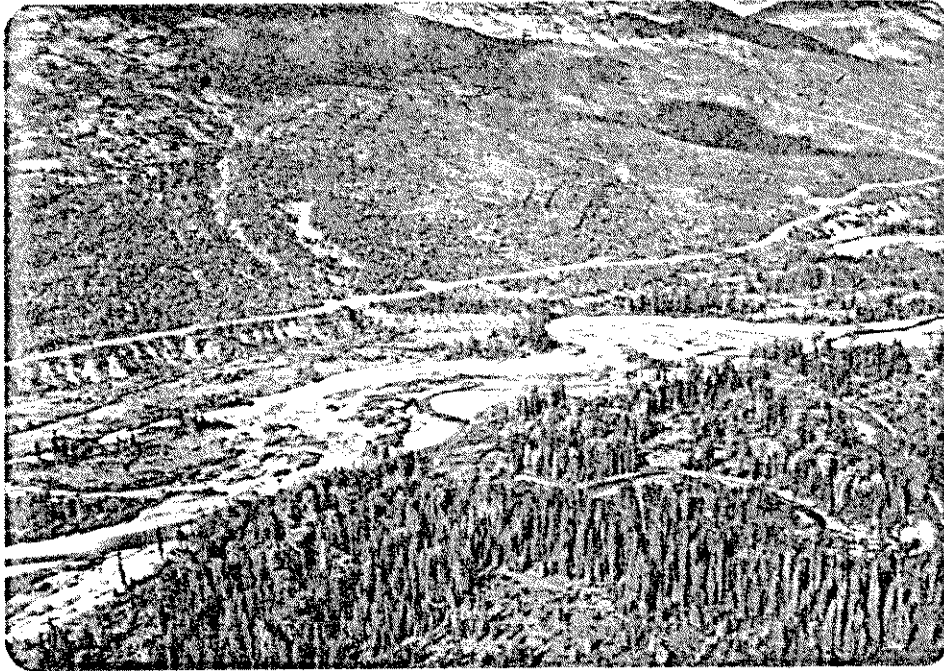
Picture 3 - Typical section of reach III illustrating wide active bed and flood plain.

Reach III, the next 14.5 km., is a relatively flat, unconfined section. The river maintains a multi-thread character throughout most of this 14.0 km. stretch, with extreme debris accumulation aiding the natural channel movement in many sections. The flow makes extensive use of the wide active/bed flood plain (picture 3) in this broad river valley (picture 4).

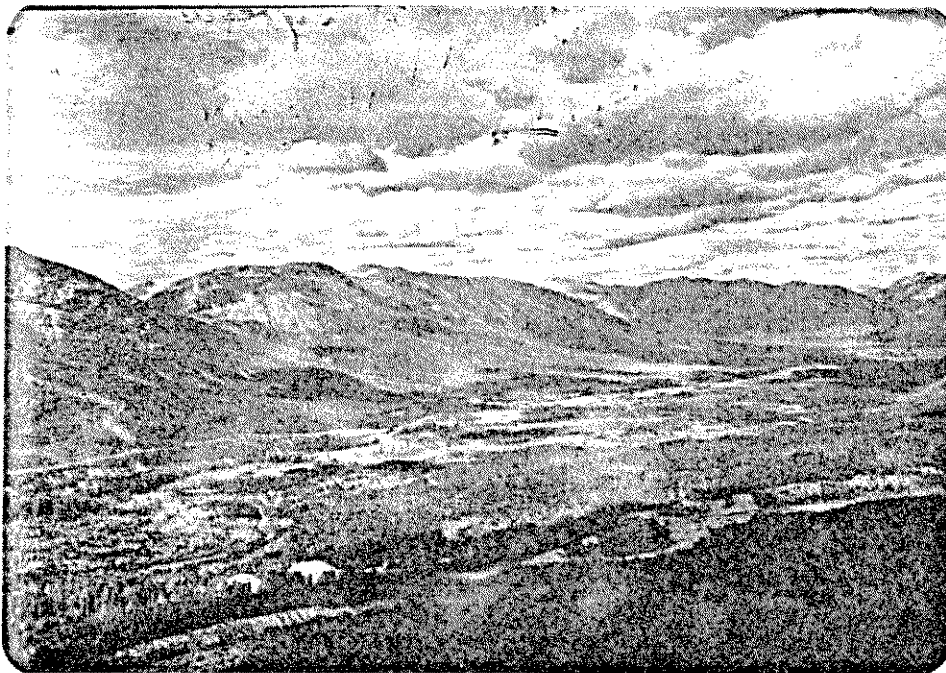
Picture 4 - The Flathead valley in vicinity of upper reach III and lower reach IV.

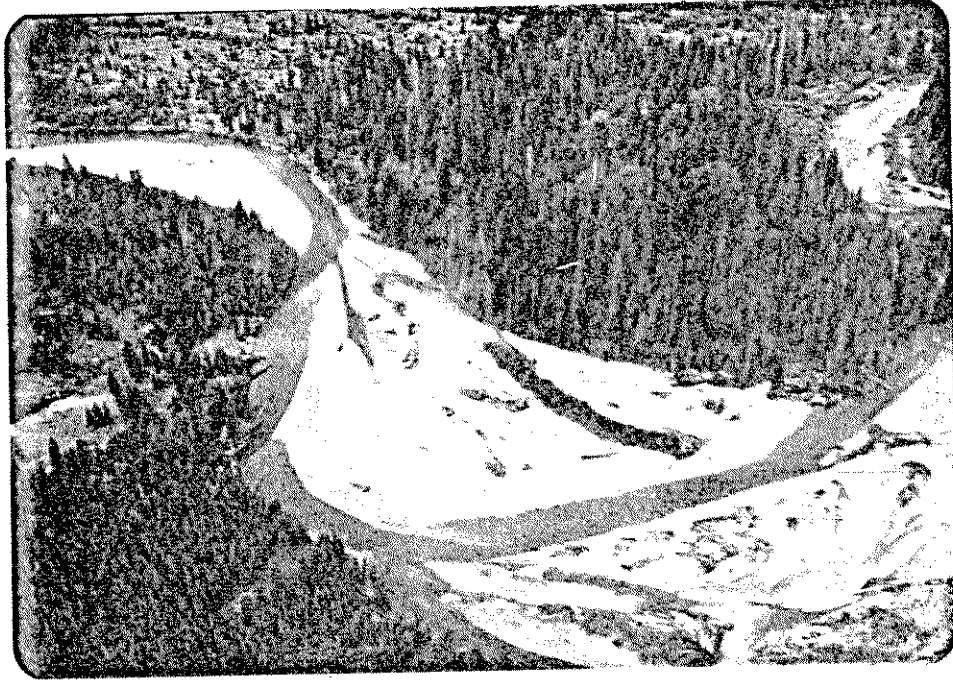
Picture 5 - Typical section of reach IV illustrating wide active bed and uniform pool-run-riffle-pool sequence associated with "step" type gradient.

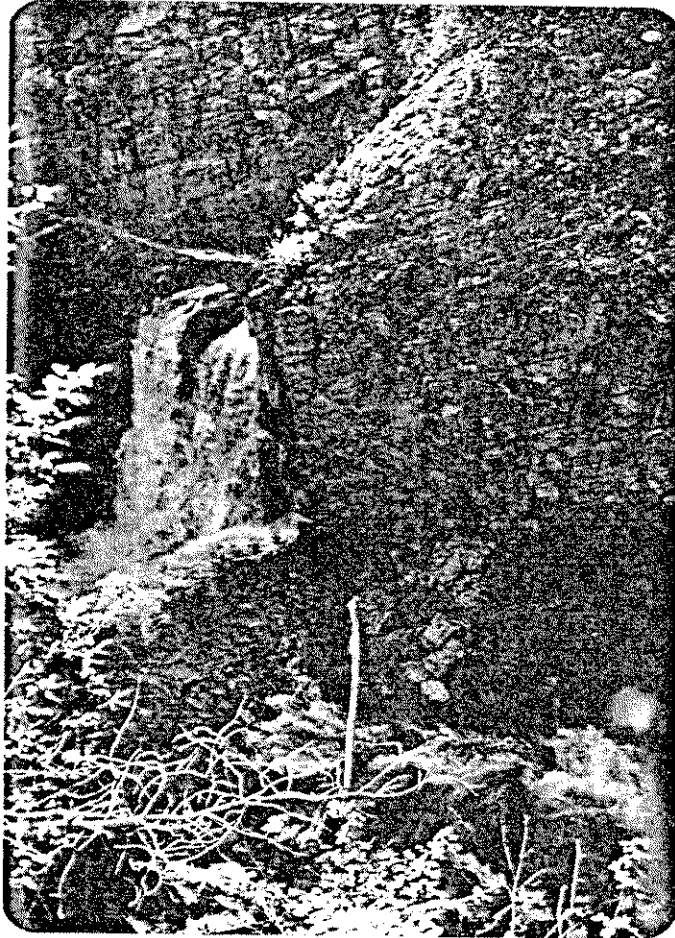
Picture #6 - 12 m. falls on mainstem Couldrey Creek, approximately $\frac{1}{2}$ km.
above mouth of Frozen Creek (map IV)

There were no fish above the falls.

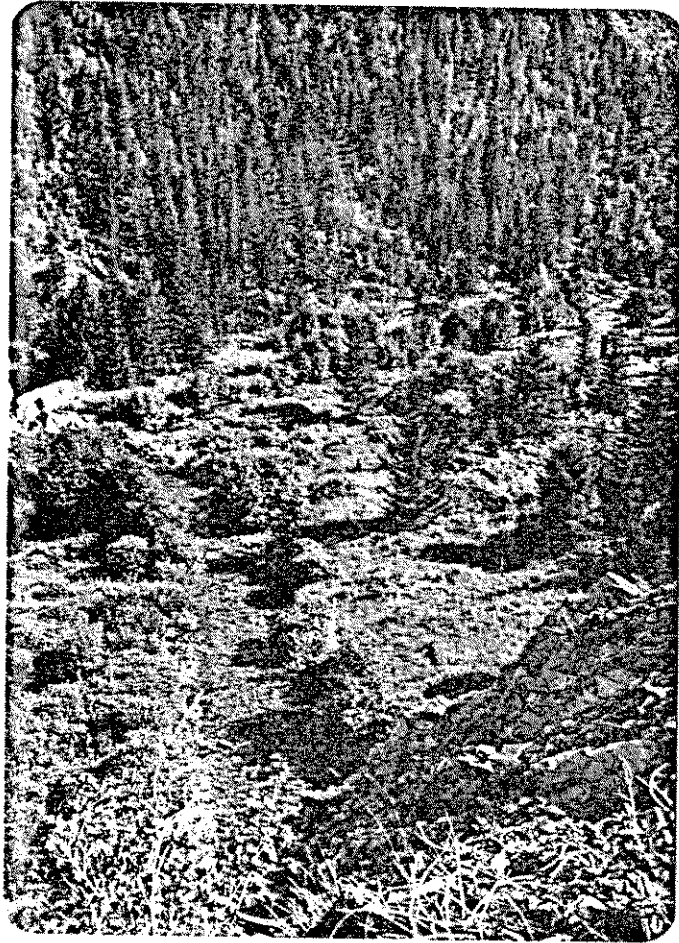
Picture 7 - Typical section of Frozen Creek - illustrating grassy shrub covered undercut banks and typical flow pattern.

Picture 7 illustrates the two major vegetation types found along Frozen Creek i.e., variation from

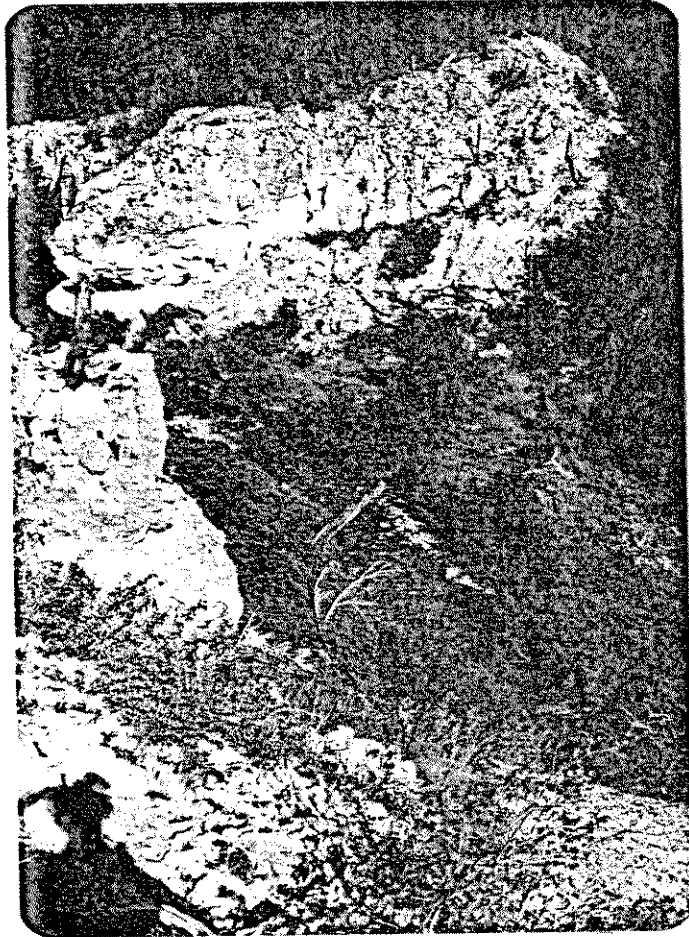
Picture 8 - Bedrock section below picture 7 - illustrating high % run type flow and high % rubble substrate composition.

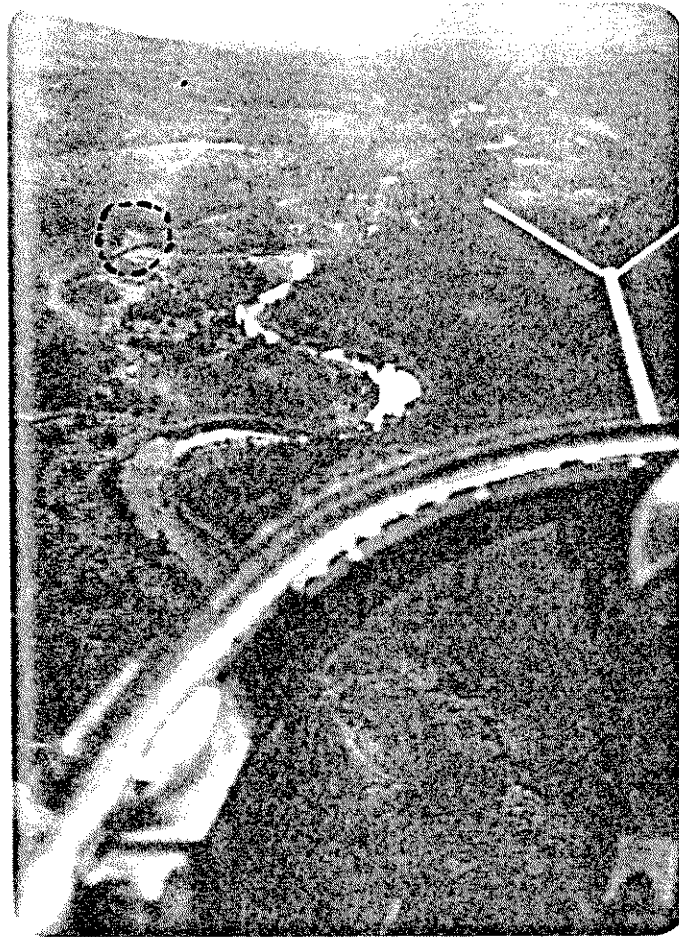
Picture 9 - Winding flat section of Howell Creek (reach II) note slumping bank in top left.

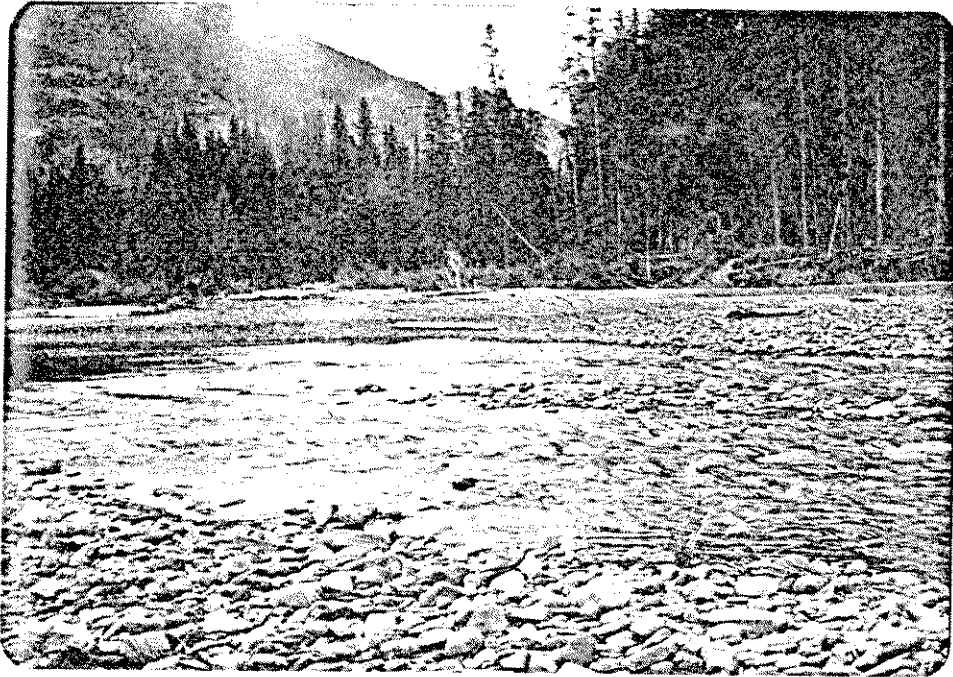
Picture 10 - Kishenina electroshocking site 11.5 km. from mouth.

The actual shocking site is shown in picture 10. It was surprising that in this section no fish were found in a nearby side channel, but instead were found amongst the rubble in the foreground. It appeared that the spaces between the rubble offered more protection than the rather barren side channels.

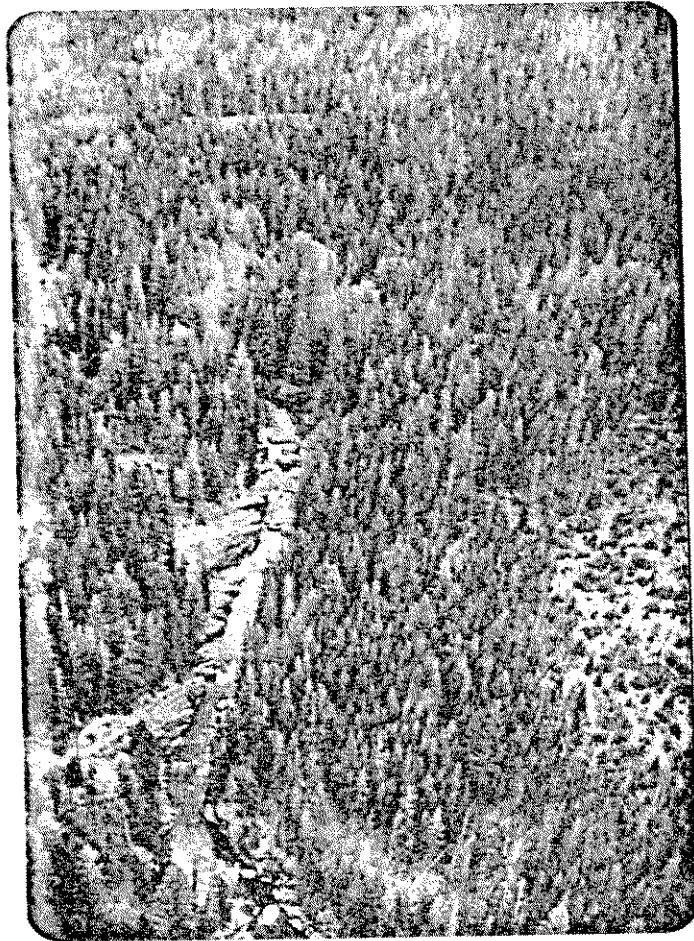
Picture 11 - Beginning of confined bedrock section 17.0 km. from mouth.

over the first 7 km. with % rubble increasing to 60% over the next 4.0 km. A typical section of this high % rubble section is illustrated in picture 11.

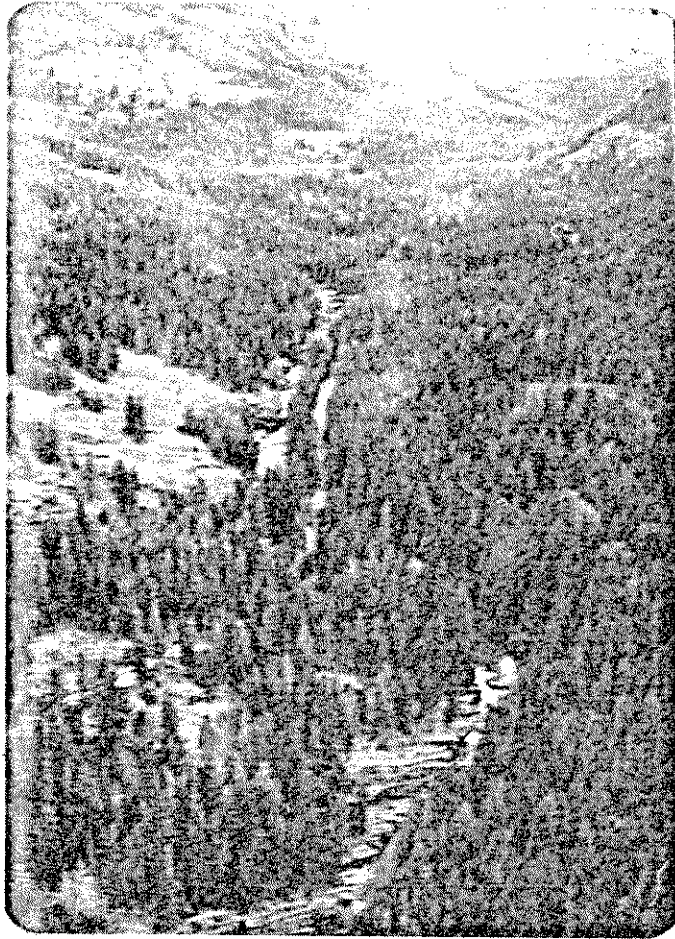
Picture 12 - Bedrock channel with chutes (barrier)

There was no fish found above the 18.0 km. barrier. Electroshocking at 11.5 km. yielded the following

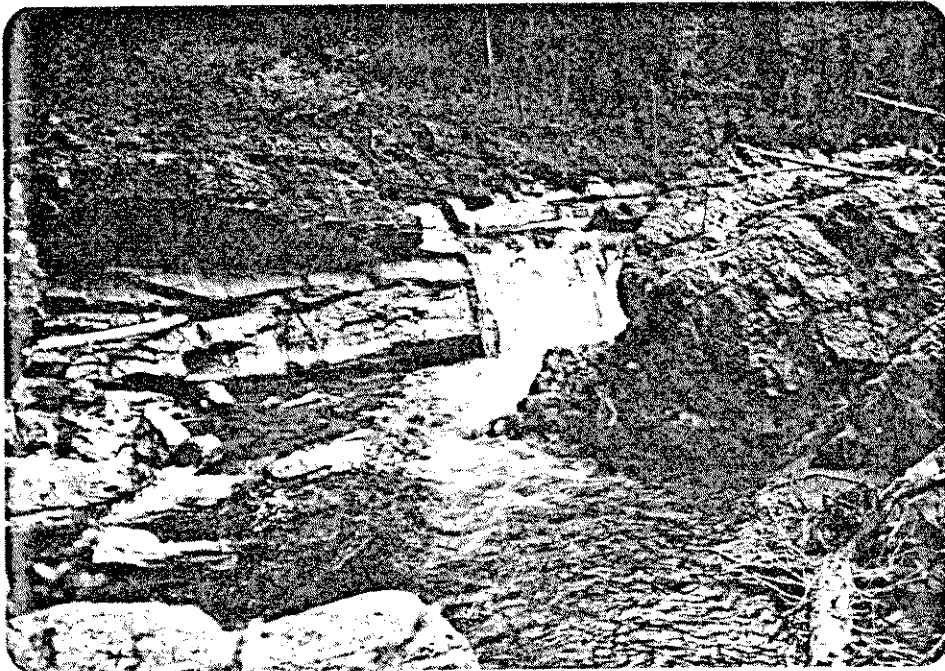
Picture 13. - Falls 20 km. from mouth - person in middle right for perspective.

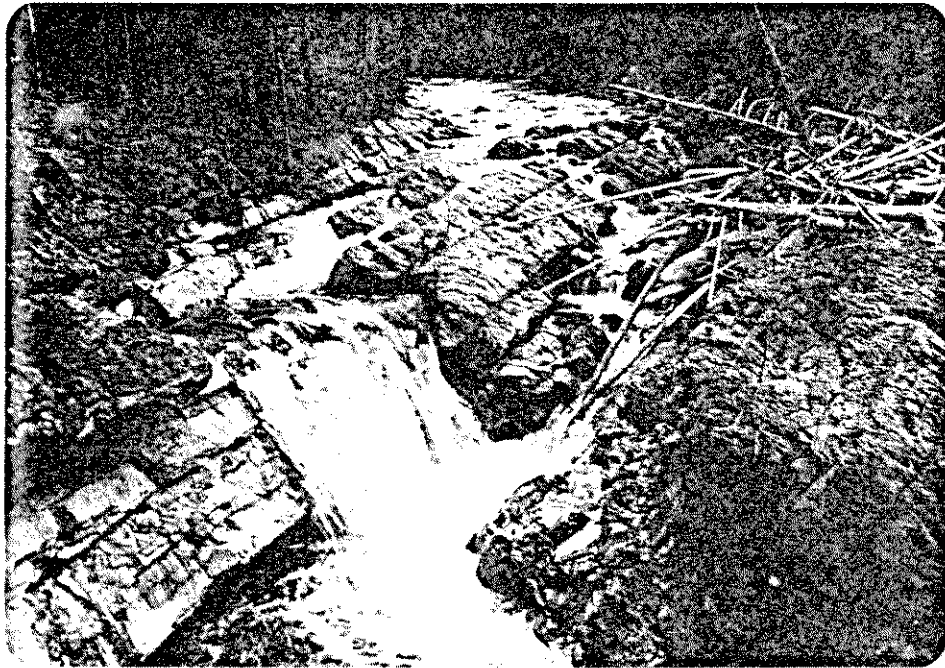
Picture 14-. 5 m. falls at 20 km. showing stream channel above.

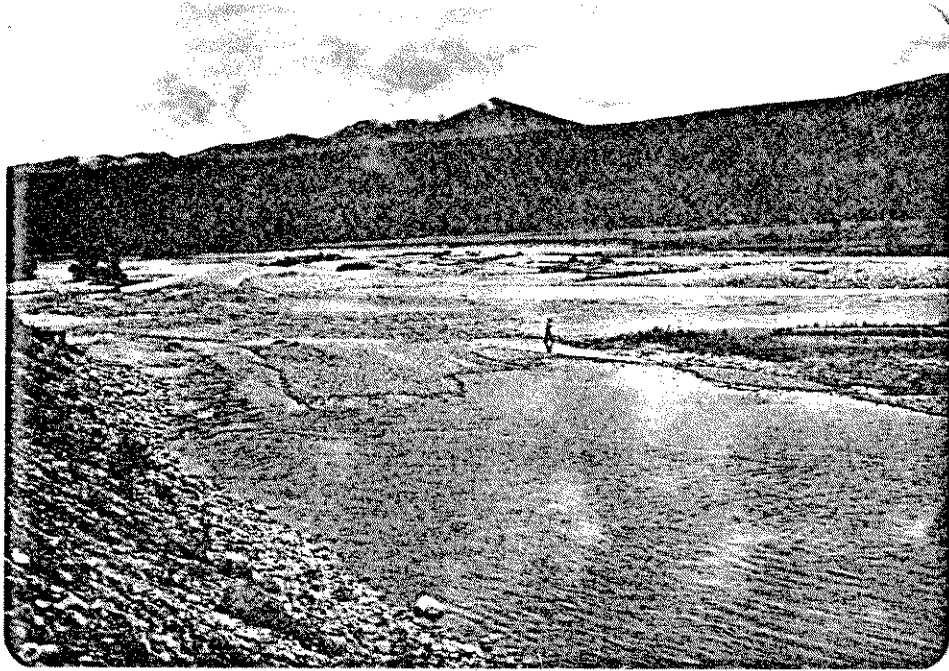
Picture 15 - Mouth of Sage Creek showing entry into river.

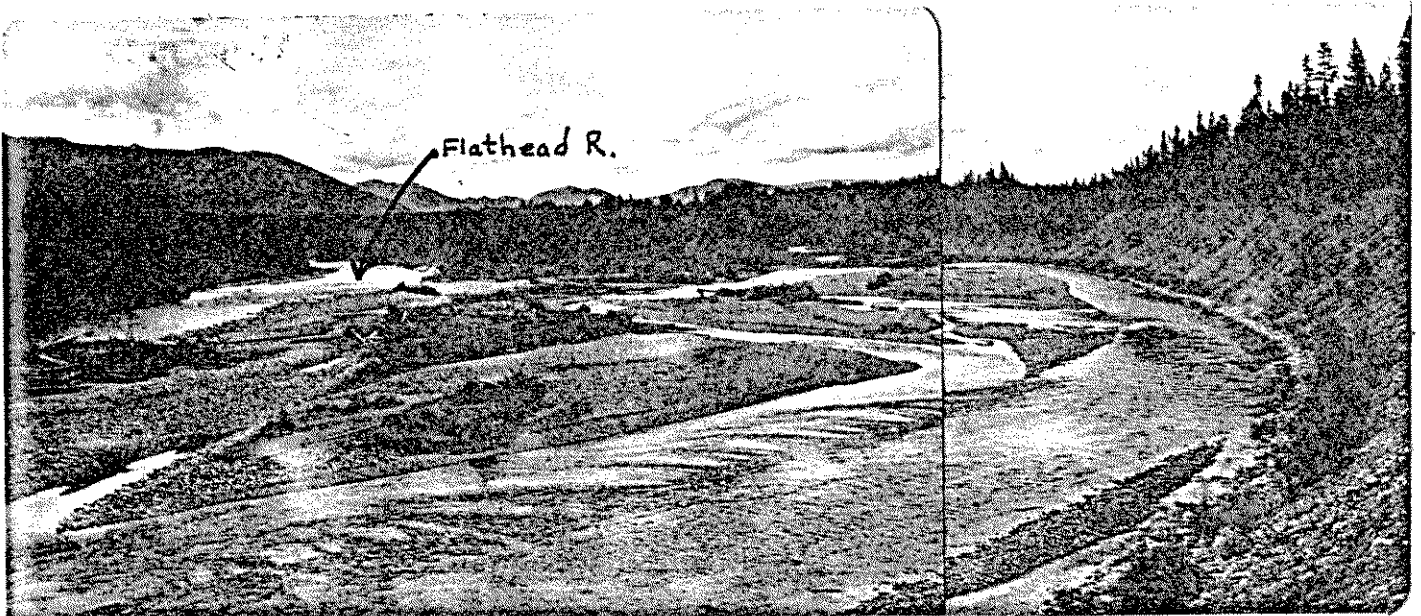
Picture 16 - looking upstream from Sage Creek mouth illustrating wide active bed flood plain and loose unstable bank.

A very high % loose unsorted sand gravel rubble. Picture 16 illustrates the high loose banks at the mouth, very common in form throughout the Flathead drainage. Picture 19 illustrates above the falls a similar situation in the finer high% clay material. Note the slumping banks with runoff channels in picture 19 and compare to pictures 15 and 16. A combination of finer bank material and water movement throughout the clearcut has increased the bank instability above the falls. Generally we have a movement from coarse to fine material as we move upstream from the mouth. The lower portion being largely sand gravel with the upper drainage being a high percentage clay silt with some sand/gravel.

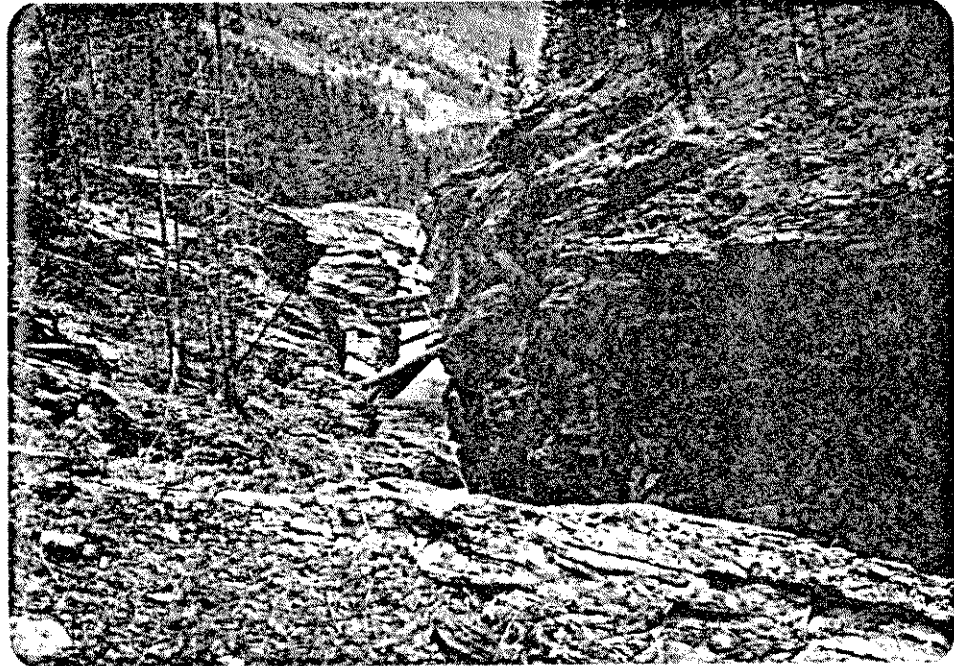
Picture 17 - Reach break between reaches II and III at 18 km. Deeply insised channel with successive chutes and falls. Total Barrier to migratory fish.

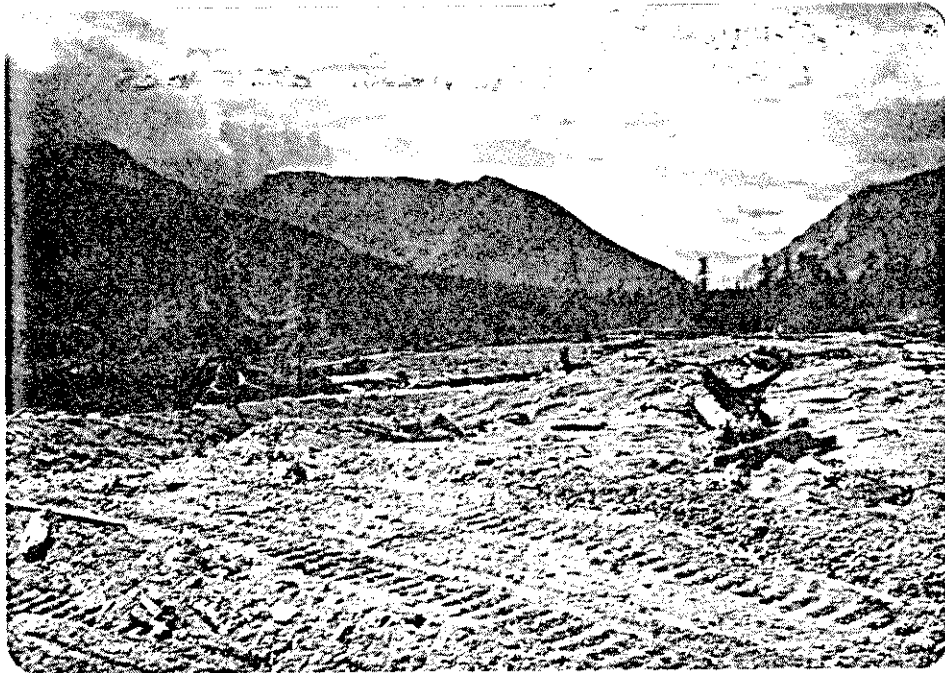
Picture 18 - Sage above falls looking downstream from mouth of Roche Creek into the valley of Reach II.

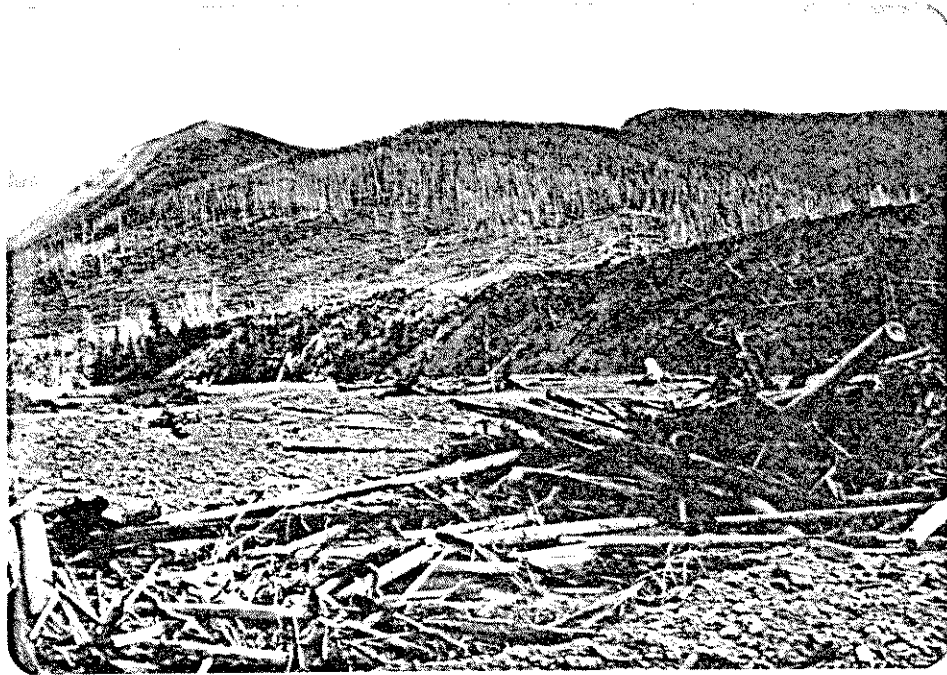
Picture 19 - Sage Creek above falls looking upstream from Roche Creek - Note fine bank material with slumping and drainage channels. Wood debris and signs of channel movement characterize lower reach III.

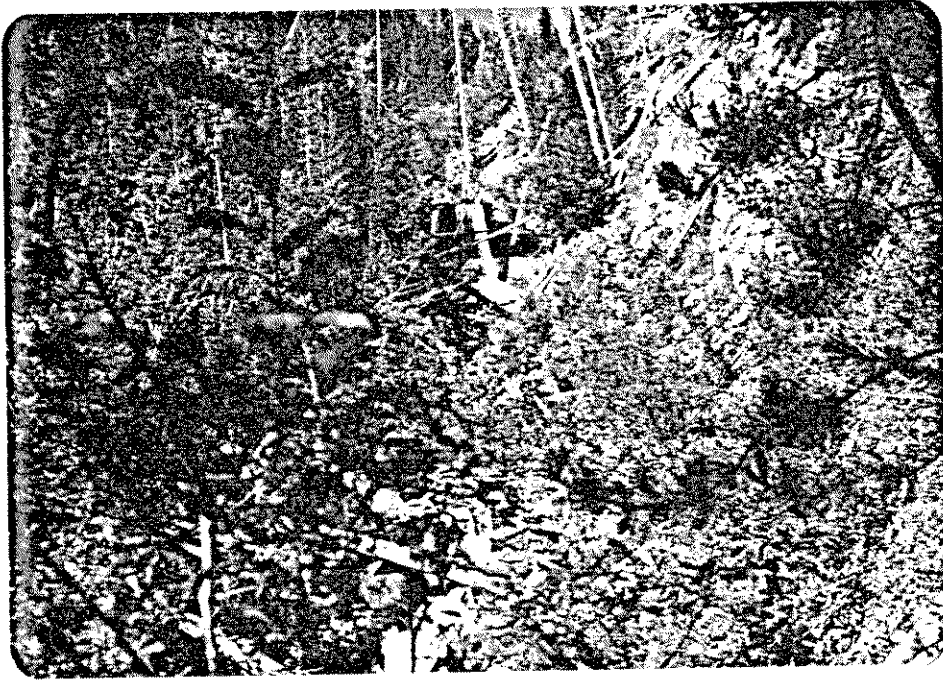
Picture 20 - Tributary #1 1.5 cm. from mouth illustrating barrier, unstable banks and thick streamside vegetation.

Tributary #1 provides approximately 1.5 km. of accessible stream to migratory fish. A 4 m. falls followed by a series of 60° chutes constitutes a definite barrier. Picture #20 illustrates the barrier; the extremely unstable banks and the high percentage of debris and stream cover typical of this stream. These factors are not nearly to extreme in the unconfined lower 1.5 km. Log jams are prevalent in this lower portion.

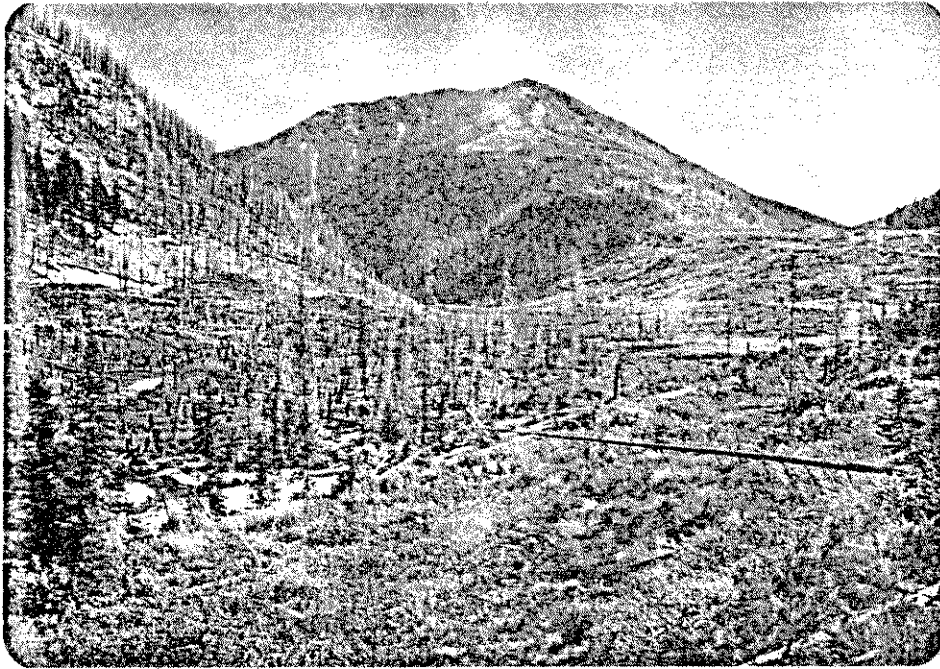
Picture 21 - Harvey Creek Valley - looking down from 10.0 km. from mouth (reach II)

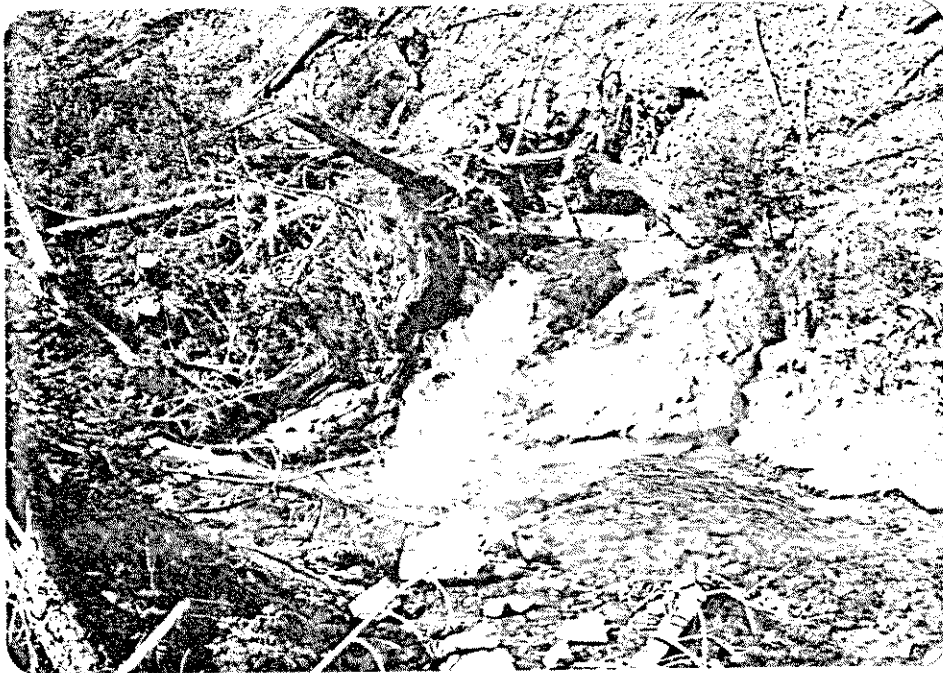
Picture 22 - Harvey Creek - chute - 9.0 km. from mouth.

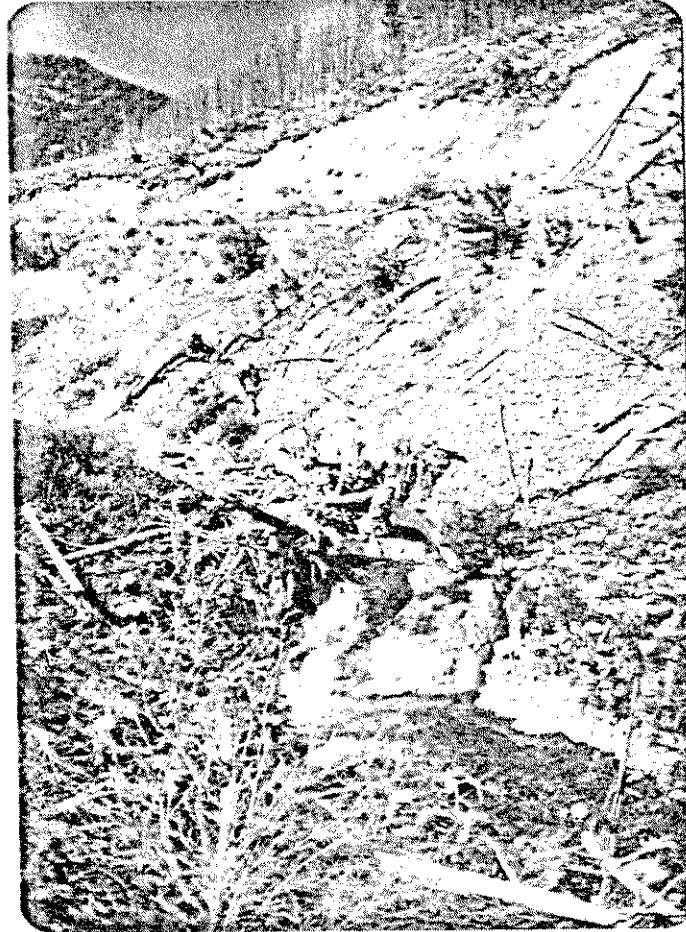
Picture 23 - Harvey Creek chute (9.0 km.) showing unstable bank associated with old road above...
